Metro Boston Property Inspections, Inc.
575 Washington Street Unit 2C
Canton MA 02021
781-828-1972
office@metroboostonpropertyinspections.com
www.metrobostonpropertyinspections.com

Inspection reference: 7452-431 West Street

Confidential Inspection Report

Mold Assessment

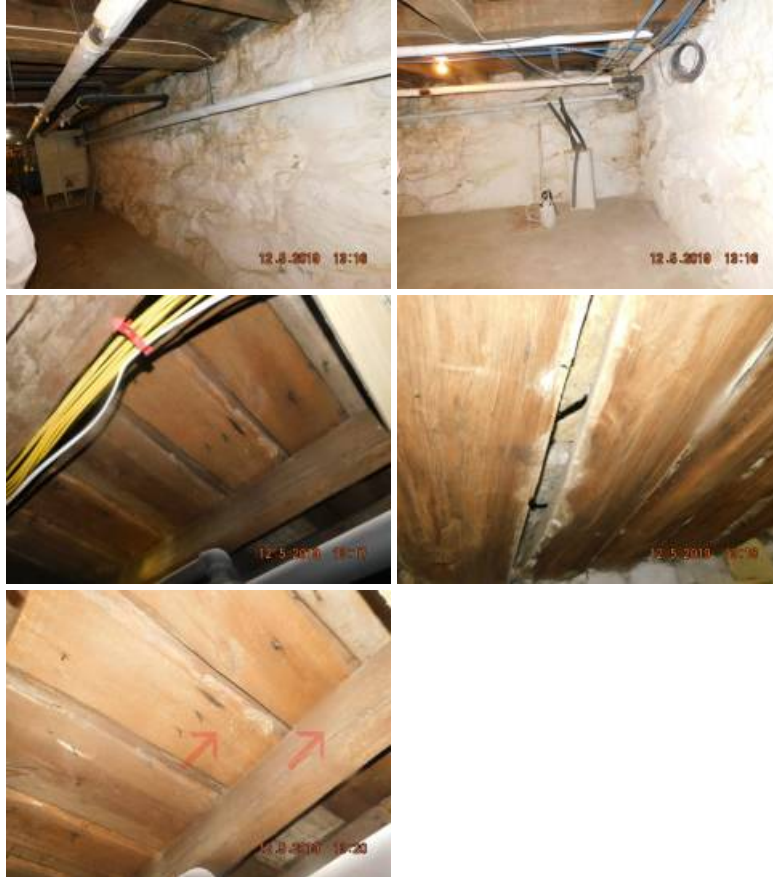
Basement. Dust and debris were built up on the foundation wall. Dust is a food source associated with mold growth.

Yes, moisture penetration is noted at the bulkhead.

yes. Mold growth noted on the foundation wall and floor joists.

The laboratory analyses by Hayes Microbial for the indoor surface samples extracted from each location of the subject indicated the presence of mold growth. The dominant genera of mold in the basement is Cladisporium type spores on the floor joist/subfloor and Stachybotrys type spores on the foundation wall. See lab report for actual spore counts

- d. All non-essential items stored in the basement and under floor crawlspace should be disposed.
 - e. HEPA vacuum and damp wipe all exposed/unprotected surfaces in the basement, especially the foundation walls and the concrete floor.

- f. Abrasively remove all visible growth and or staining from the exposed structural framing components as well as any plywood or wood surface where removal is not possible

- h. After the visible growth has been removed seal all porous, semi porous and non-porous surfaces with an industry accepted anti-microbial sealant to inhibit future growth.
